# Manhole Inspection Summary

Manhole # S02GG2006MH

Insp Date: **7/17/06 9:54 AM**

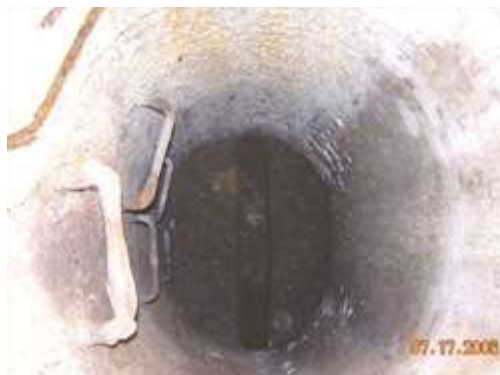
Top View

Evidence of surcharge - Bench debris.  
Channel debris. Corroded steps.

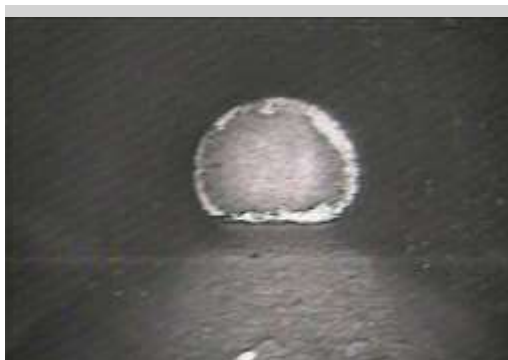
Inside the I6

Plugged.

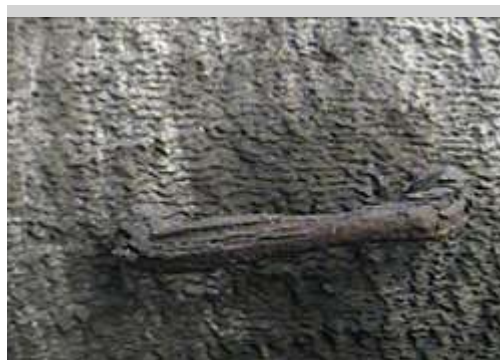
Defect

**Steps** Count: **7** Missing: **0** ☒ **Corroded**

Corroded step.

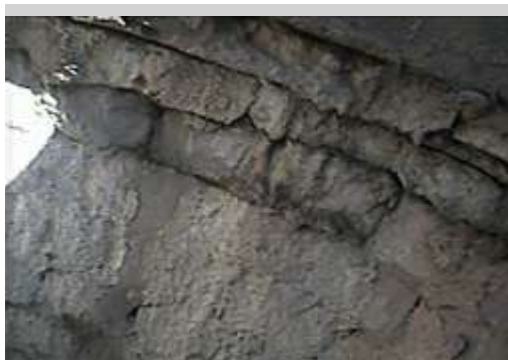
Defect

**Frame** Offset: **2** (in.) Condition: ☐ Sound ☐ Cracked ☒ **Leaks**

Condition: ☐ Sound ☐ Cracked ☐ Root Intrusion ☐ Loose Brick ☒ **Deteriorated**

Infiltration: ☐ None ☒ **Joint** ☐ Cracks ☒ **Mortar** ☐ Roots ☐ Wall

Frame leaks. Adjustment deterioration  
and infiltration.

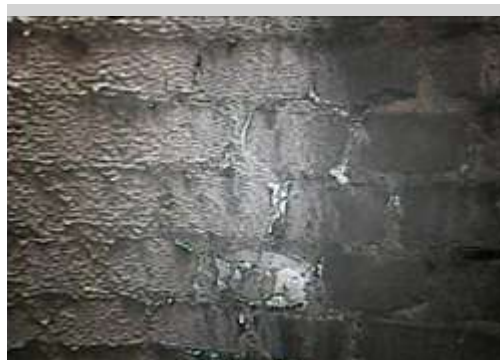
Defect

Adjustment infiltration - mineral deposits.

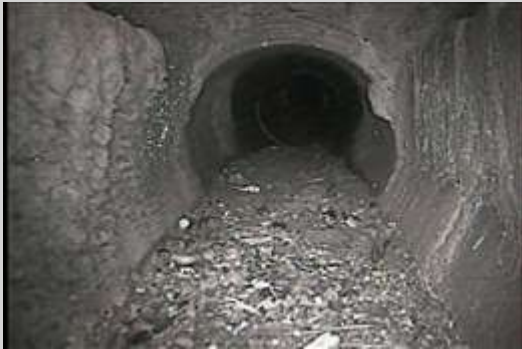
### 8 in. Circular Gravity Sewer Pipe Out @ 12 O'Clock

Deposits: ☐ None ☒ **Mud** ☐ Sludge ☒ **Debris** ☐ Grease

Silt Depth: **0.5** (in.) Deposits Extent: **Light**

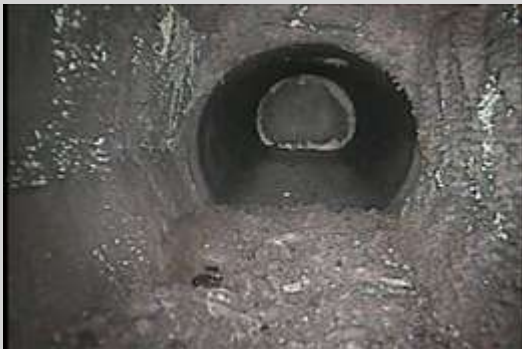
### Pipe In @ 6 O'Clock

Connects To: **Stub connection / abandoned**
